SERVICE BULLETIN SB-11

Propeller Governor P-W22-3, P-W25-3 and Beta Switch P-S-2B

- 1. This Service Bulletin describes procedures to upgrade the propeller governor from P-W22-1 to P-W22-3 and from P-W25-2 to P-W25-3.
- 2. This Service Bulletin describes procedure to exchange the beta switch P-S-2A with P-S-2B.

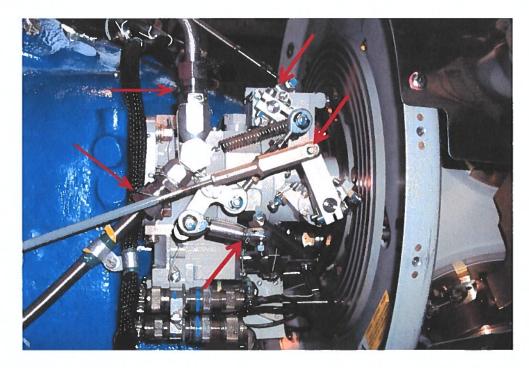
- 2. Remove beta switch P-S-2A from engine gear box by releasing four screws (together with beta lever support bracket).
- F. Upgrade of propeller governor procedure
 - 1. Disconnect control linkage, disconnect hydraulic tubes. The arrows show where to disconnect governor interfaces, seal tubes and governor fitting with suitable caps.
