AVIA PROPELLER Ltd Beranových 65/666 199 00 Praha 9 Czech Republic	<b>SERVICE BULLETIN SB-9A</b>	DOA No. EASA.21J.072
---	-----------------------------------	-------------------------

**AV-725-1-E-C-F-R(W)**

## **INSPECTION OF BETA FEEDBACK MECHANISM**

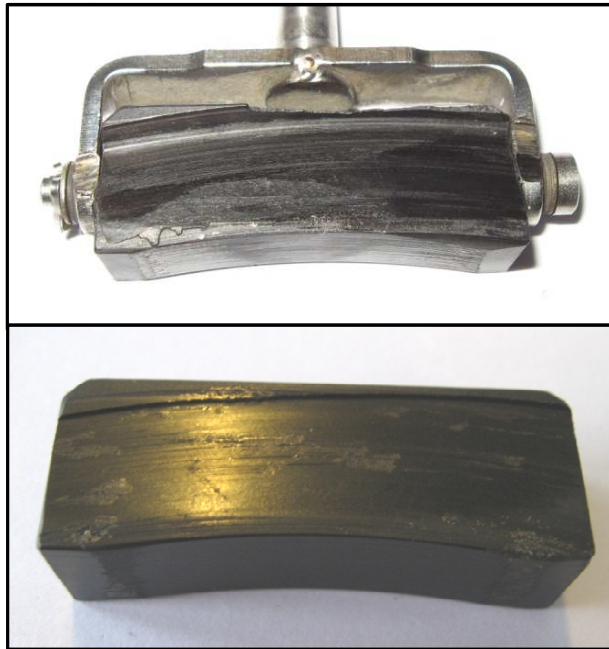
- (1) In service events of damaged slip ring caused by excessive wearing of the carbon block exceeding the limits prescribed in Avia Manual No.EN-1320. See figure 1.
- (2) It appears that carbon block is not regularly inspected for excessive wear as prescribed in Avia Manual No.EN-1320.

FIGURE 1: Excessive wearing of the carbon block

- (1) Perform this inspection before the next flight.
- (2) Excessively worn carbon block must be replaced before the next flight.
- (3) Make an entry in the Propeller Logbook documenting the inspection in accordance with this Service Bulletin.
- (4) Regularly inspect the beta feedback mechanism as required in Avia Manual No.EN-1320. Refer to Pre-flight Inspection and 300-hour/Annual Inspection, which include the inspection of beta feedback components.
